The following describes the findings of the inspection of the onsite wastewater treatment system at:

Inspected: 735 County Rd 2 Lansdowne

Date: July 31, 2024

The following pictures accompany the report of findings for the inspection of the onsite wastewater treatment system at:

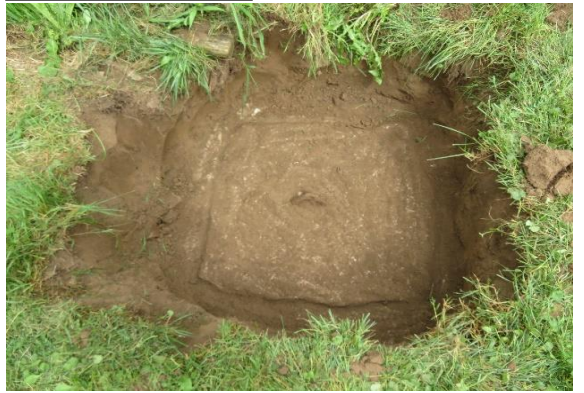
- 1 A flow test could not be performed due to conditions and liquid levels within the tank.
- 2 Toilet at 2nd floor bathroom has a lazy flush wich may also be an indication of non preformance
- 3 The onsite sewage system was not functional at the time of inspection. Recommend further evaluation and repair estimates are provided by a qualified contractor.
- 4 Note: Results may be more favourable when there has been a lack of regular use.
- 5 Note: Treatment tank lid is excessively heavy and requires equipment to access.

Excessively heavy lid

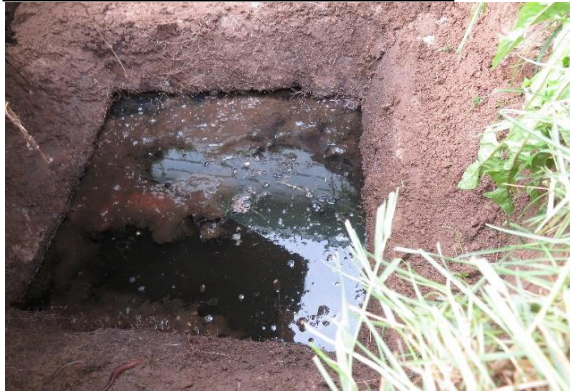
Liquid level in tank

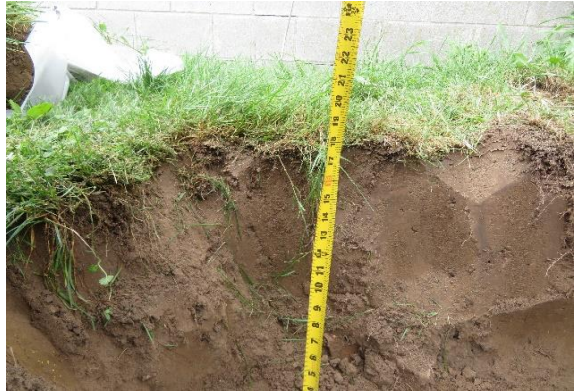
Depth to top of tank
